LAKE CLASSIFICATION SHORT REPORT EASTON LAKE, ADAMS COUNTY, WI

Presented by Reesa Evans, Lake Specialist Adams County Land & Water Conservation Department P.O. Box 287, Friendship, WI 53934

JULY 2007

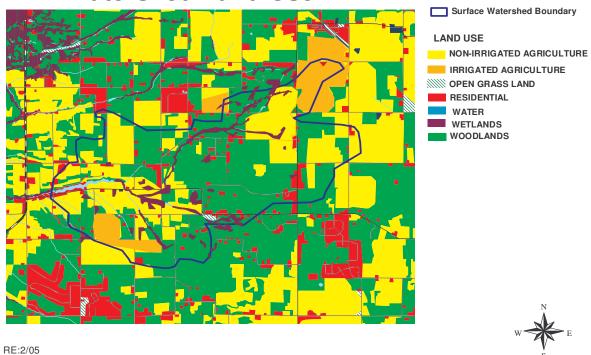
Easton Lake Surface Watershed Land Use

29.29% of the surface watershed for Easton Lake is in non-irrigated agriculture. Irrigated agriculture accounts for 30.88% of the surface watershed land use. Traditionally, agriculture contributes significantly to the amount of nutrients in water.

Residential land use is the third most common land use category in Easton Lake watersheds, especially around the lake itself, where residential land use is most concentrated. This land use category may also contribute nutrients to the water from stormwater runoff, due manicured lawns and impervious surfaces.

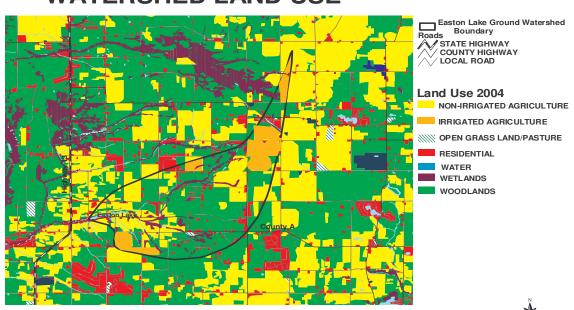
EASTON LAKE GROUND WATERSHED LAND USE

The next largest contributor is the ground watershed, covered largely by woodlands (44%) and agriculture (41%). Most of this probably comes from agricultural lands in the ground watershed.

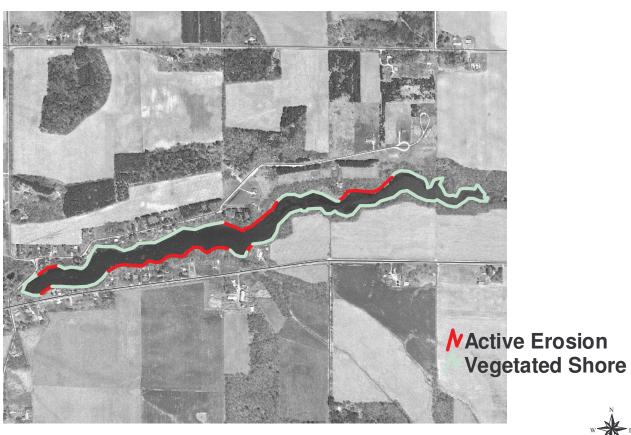
Easton Lake Shoreline Map

Easton Lake has a total shoreline of 2.11 miles (11,140.8 feet). Much of the lake shore is in residential use. Most of the areas near the shores are steeply sloped, except at the far northwest end, where the land is flatter. Several buildings along the shore are located very near the water line. Additionally, much of the shore has active erosion that is likely to be negatively impacting the water quality of the lake.

- Lake residents should protect and restore natural shoreline around Easton Lake. There is a significant amount of eroding shoreline that needs to be stabilized.

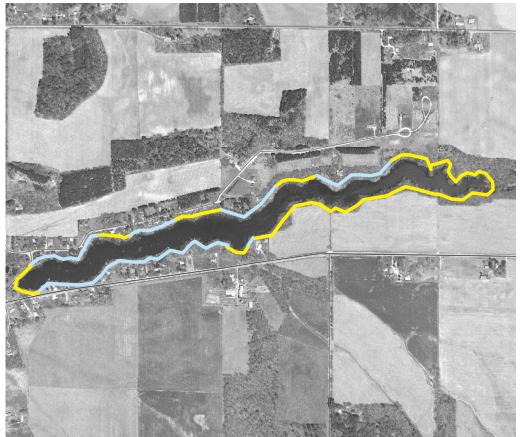
Easton Lake Buffer Map

Native vegetation covers 68% of Easton Lake's shoreline. However; a 2004 shore survey showed that only 46% of the shore had an "adequate buffer." An "adequate buffer" is defined as a native vegetation strip at least 35 feet landward from the shore.

Most of the "inadequate" buffer areas were sections with mowed lawns and insufficient native vegetation at the shoreline to cover 35 feet landward from the water line.

ADEQUATE BUFFER INADEQUATE BUFFER
